# Manhole Inspection Summary

Manhole # S29CC\_020MH

Insp Date: **11/19/07 2:09 PM**

**Location** Address: **545 DOLPHIN ST**

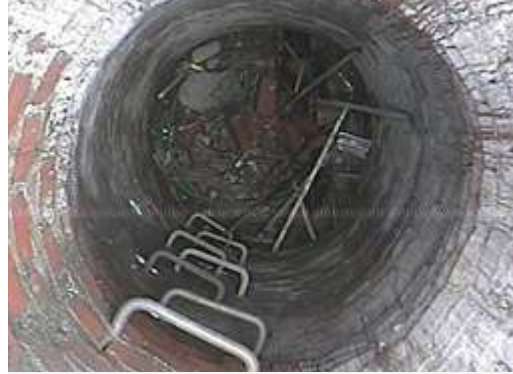
Top View

DEBRIS IN CHANNEL

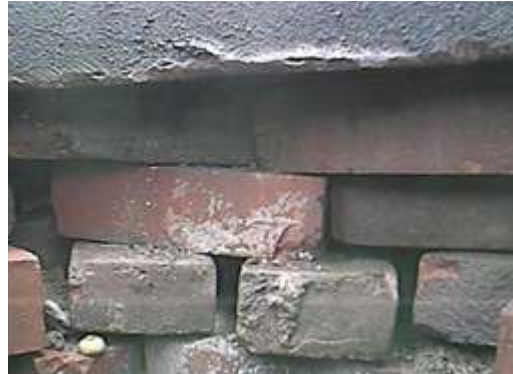
Defect 1

Condition: ☐ Sound ☐ Cracked ☐ Root Intrusion ☒ Loose Brick ☒ Deteriorated

LOOSE BRICKS IN ADJUSTMENT

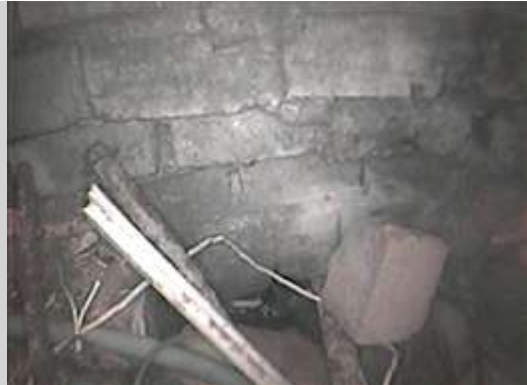
12 O'Clock Outflow

TOO MUCH DEBRIS FOR CLEAR PHOTO

Deposits: ☐ None ☒ **Mud** ☐ Sludge ☒ **Debris** ☐ Grease

Silt Depth: **6** (in.) Deposits Extent: **Medium**
